Condition Report and Treatment Proposal

Title: George Washington
Location: W. Wisconsin Ave at N 9 th St. (Median) Milwaukee, WI
Owner : City of Milwaukee
Artist: Richard Henry Park
Material: Bronze on Granite base
Dated: 1885
Examined: 08-03

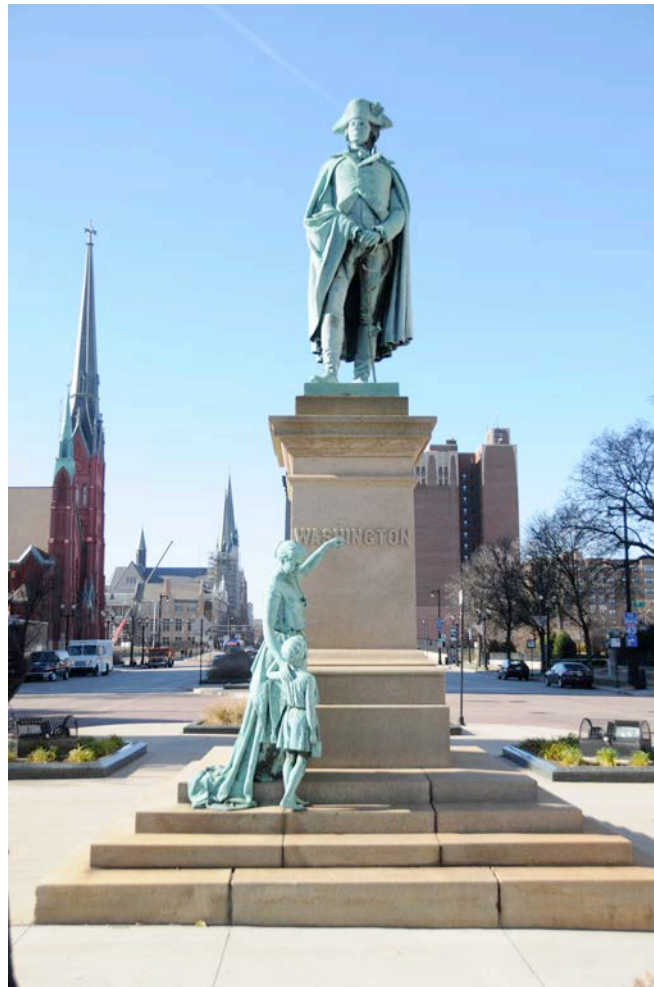
The sculpture has been exposed to an outdoor environment for a number of years. The entire surface is covered with dirt, dust, and corrosion which disfigure the intended design of the monument.
